Evaluation of Damage of Roundwood Assortments Caused by Varied Construction, Technical Solutions and Conditions of Harvester Head Feed Rollers

Ziedonis Miklašēvičs

Rezekne Academy of Technologies

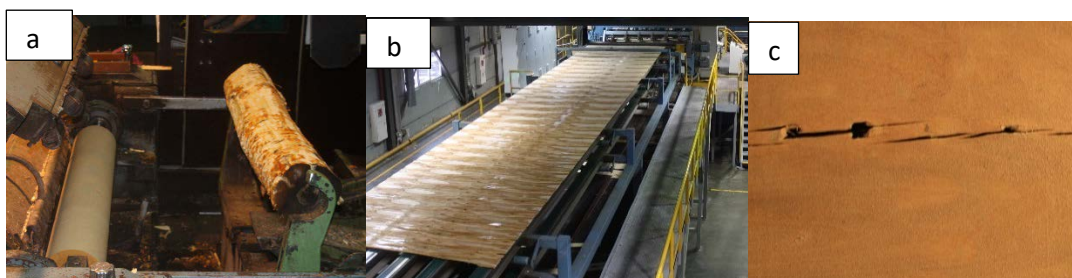
Fig.1. Cut veneer manufacturing process (a;b) and rejected veneer (c) caused by feed roller penetration in timber

In rotary cut veneer manufacturing when the thickness of veneer is 1.26mm and the birch veneer log rotary cilinder is 25cm, the lenght of gained veneer in peeling process is 28.9m. If the cilinder surface damage caused by feed rollers reaches 10mm, veneer in lenght 3.1m (10.7%) will be rejected because of inadequate quality.

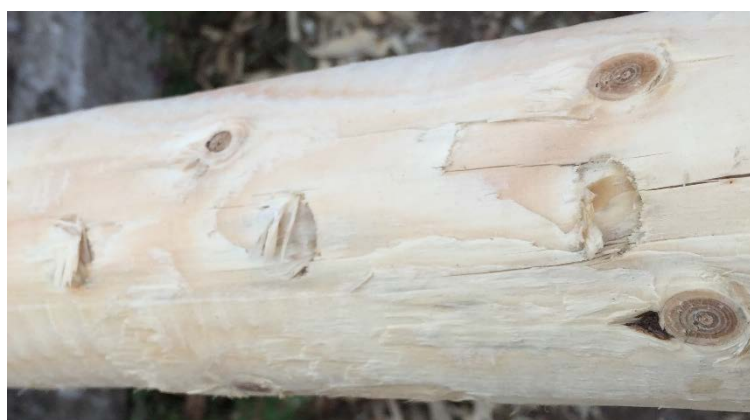
Fig.2. Roundwood surface damage caused by feed roller penetration in timber

In posts manufacturing process, if the roundwood (top diam.10cm) surface damage caused by feed rollers reaches 10mm, a greater depth of wood requires to be

removed. The technological timber loss in manufacturing process will reaches 19%.

The deepest penetration point in most damaged zone of objected assortment caused by inner or outer feed rollers was measured under bark (u.b.) by using penetration calliper (Fig. 2). The measurement zone was chosen in 50cm lenght. The measurements were

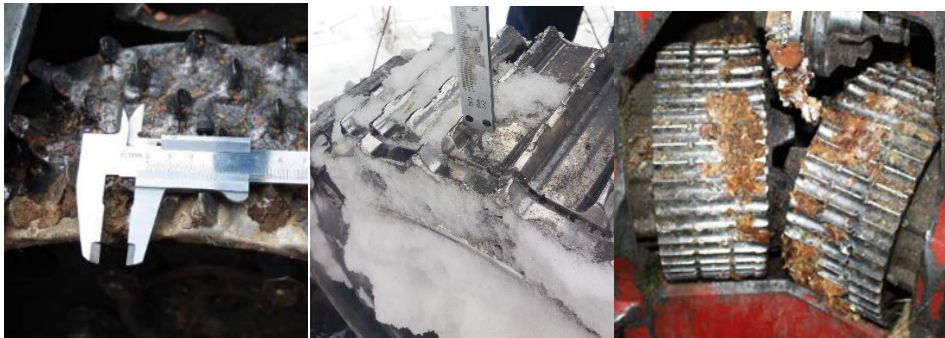
Fig.3. The lenght measurement of the feed roller spikes and evaluation the visual quality

Data characterized the technical solutions and conditions of the studied feed rollers is given in "Table1". According to the investigation objective, the average lenght of the spikes were measured for each of the feed roller of observed 14 equipment (Fig. 3).

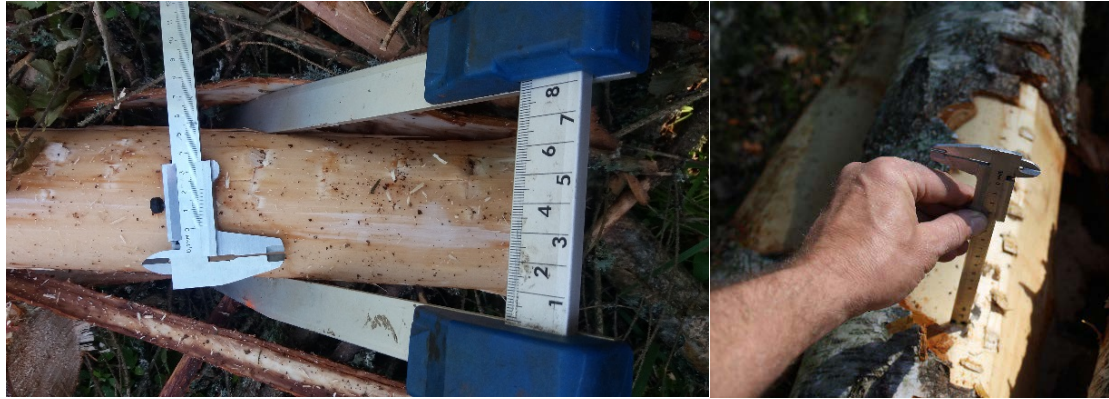
Fig. 4. The measurement of feed roller damage depth in timber

taken in sampling plots which average area was about 60m². According to the investigation task the penetration depth caused by feed rollers were observed and measured in each of objective assortments (Fig. 4).
